# Manhole Inspection Summary

Manhole # S51E\_\_019MH

Insp Date: **5/8/08 11:10 AM**

**Location** Address: **2 s decker st**

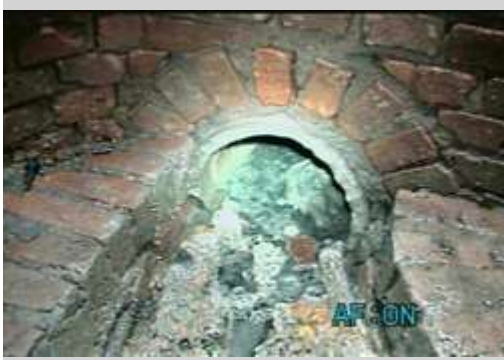
Defect 2

Condition: ☐ Sound ☐ Cracked ☐ Root Intrusion ☐ Deteriorated ☐ Leaks ☒ **Debris**

Channel Debris

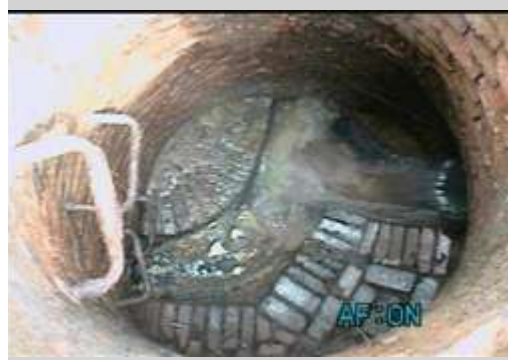
Defect 1

Count: **4** Missing: **0** ☒ **Corroded**

Corroded steps

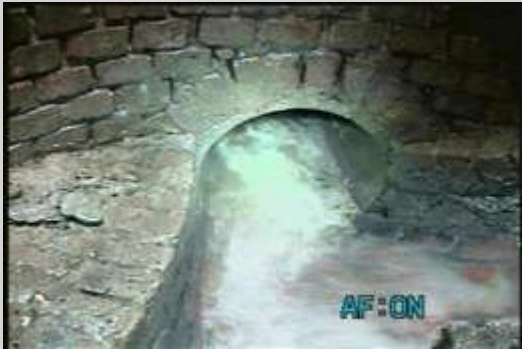
12 O'Clock Outflow

10 in. Circular Gravity Sewer  
Pipe Out @ 12 O'Clock

Deposits: ☐ None ☐ Mud ☐ Sludge ☒ **Debris** ☐ Grease

Silt Depth: 3 (in.) Deposits Extent: **Medium**

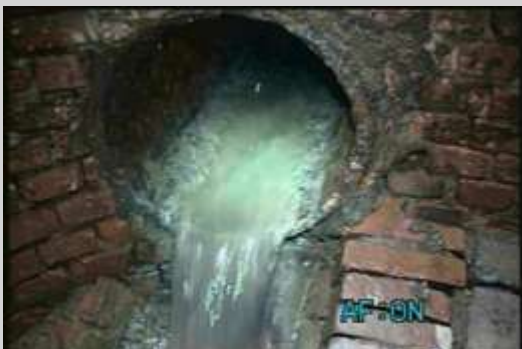
3 O'Clock Inflow

10 in. Circular Gravity Sewer  
Pipe In @ 3 O'Clock

Deposits: ☒ **None** ☐ Mud ☐ Sludge ☐ **Debris** ☐ Grease

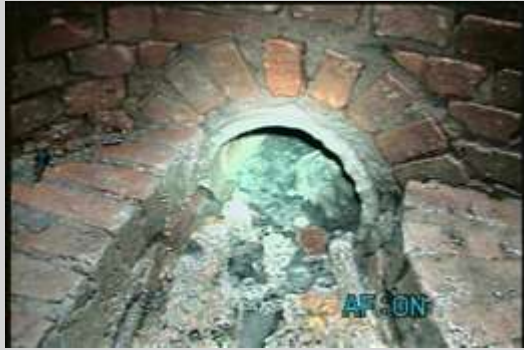
9 O'Clock Inflow

10 in. Circular Gravity Sewer  
Pipe In @ 9 O'Clock

Deposits: ☐ None ☐ Mud ☐ Sludge ☒ **Debris** ☐ Grease

Silt Depth: **5** (in.) Deposits Extent: **Heavy**
